INDOOR AIR QUALITY ASSESSMENT

**Triton Regional Senior/Middle School
112 Elm Street
Byfield, Newbury, Massachusetts**

Prepared by:
Massachusetts Department of Public Health
Bureau of Environmental Health Assessment
July, 2002

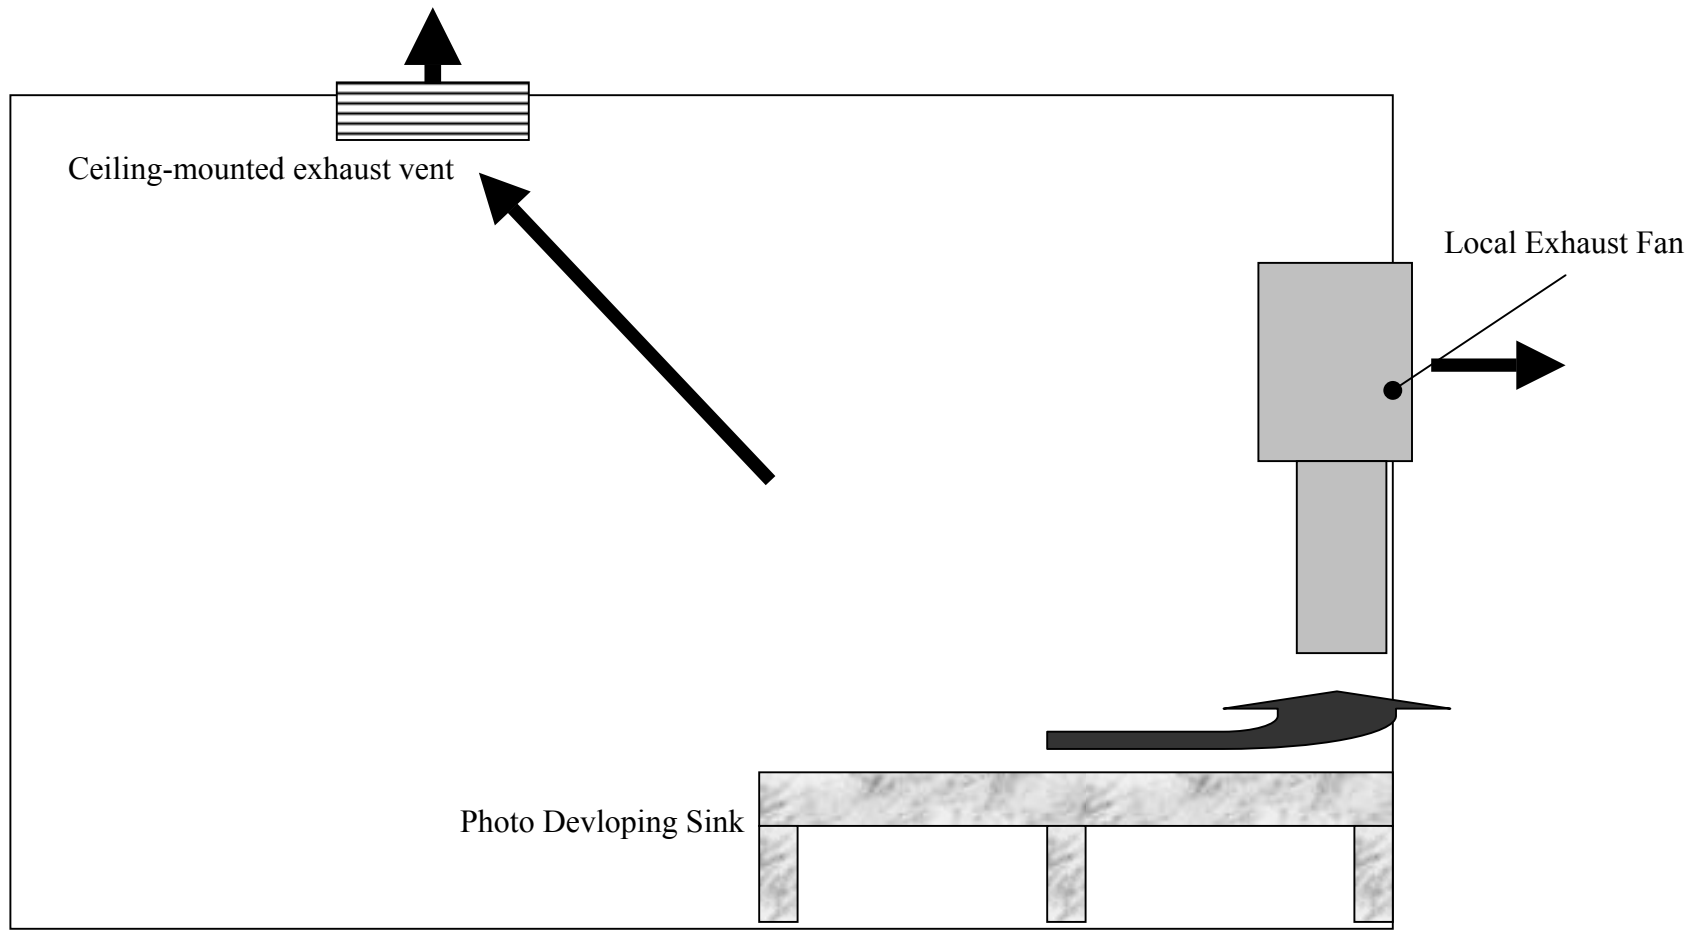
Figure 2
Photo Developing Sink and Ceiling-Mounted Exhaust Vent for the General HVAC System

A number of other conditions that can potentially affect indoor air quality were also observed. The dark room contains a local exhaust ventilation system. A ceiling-mounted exhaust vent for the school's general ventilation system is located on the opposite end of the photo-developing sink (see Picture 12). This placement will tend to draw off-gassing chemicals (against the flow of the local exhaust system) generated during film developing, which can increase exposure to volatile organic compounds (VOCs) (see Figure 2).

11. Consider sealing general exhaust vent in darkroom.
12. Reduce/trim or remove plants that are growing against the exterior brick curtain wall.
13. Reconnect dryer hose to vent and duct to outside of the building.

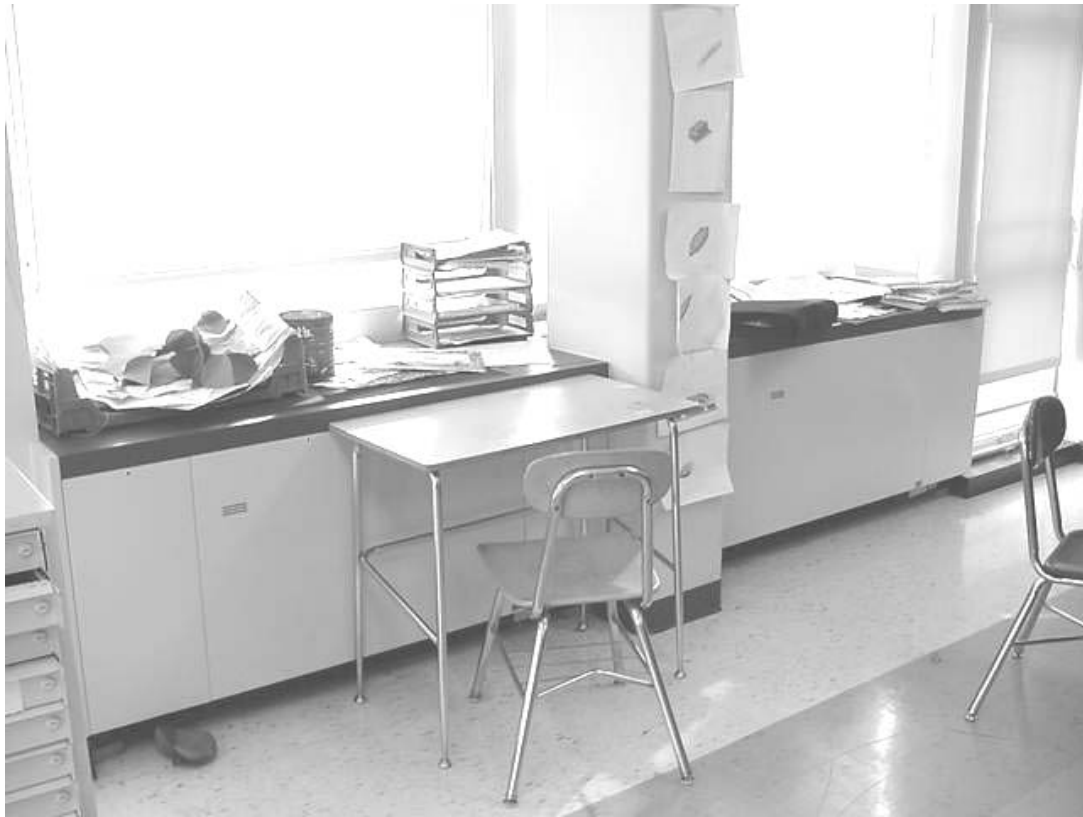
Picture 1

It can be seen from the tables that carbon dioxide levels were elevated above 800 parts per million parts of air (ppm) in eleven of forty-three areas surveyed, indicating adequate ventilation in most areas of the school. Fresh air in classrooms is supplied by a unit ventilator (univent) system. Classrooms in the new addition are equipped with a dual univent system (see Picture 1). Univents draw air from outdoors through a fresh air intake located on the exterior walls of the building (see Pictures 2a & 2b) and return air through an air intake located at the base of each unit ([see Figure 1](#)). Fresh air and return air are mixed, filtered, heated and provided to classrooms through a fresh air diffuser located in the top of the unit. A univent was found deactivated in classroom M-230. The univent was reactivated and it appeared to be operating correctly. Obstructions to airflow, such as books, papers, and desks were seen in a number of classrooms (see Picture 1), as well as items in front of univent return vents (see Picture 3). In order for

Dual Univent System, Note Materials Stored On Top Of Univent Air Diffusers Obstructing Airflow

2. Continue working with current HVAC contractor to troubleshoot problems and develop a preventive maintenance plan.
3. Remove all obstructions from univent air diffusers and return vents to facilitate airflow.

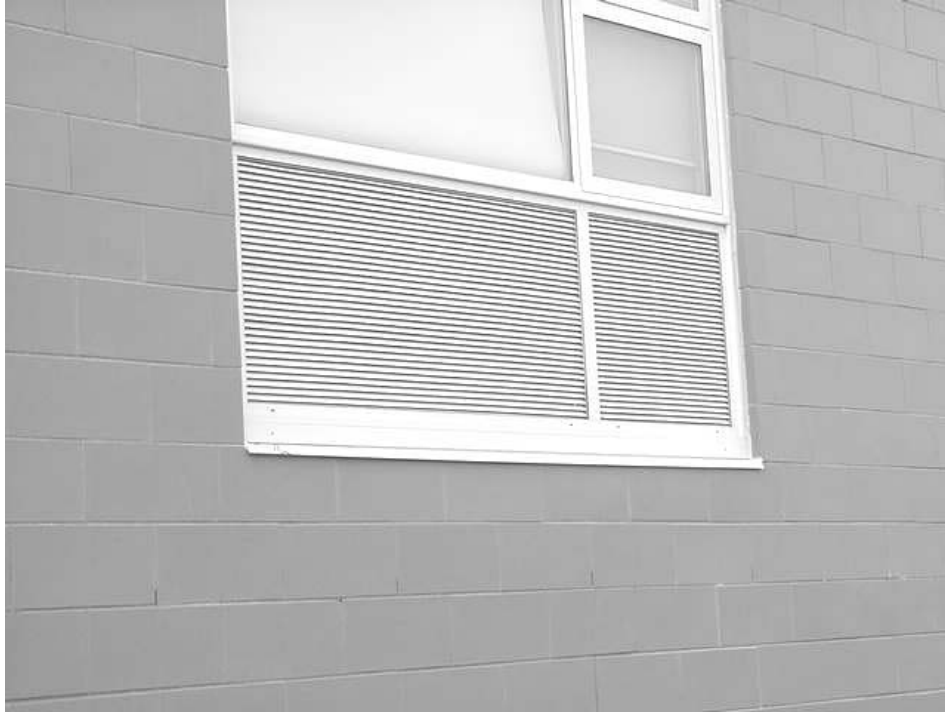
Picture 2a

Univent Fresh Air Intake

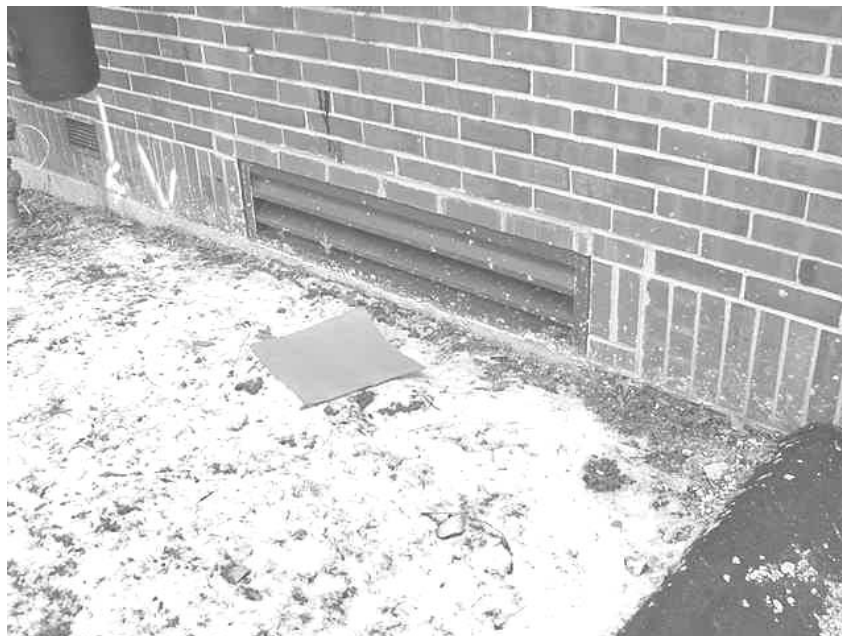
Picture 2b

Univent Fresh Air Intake

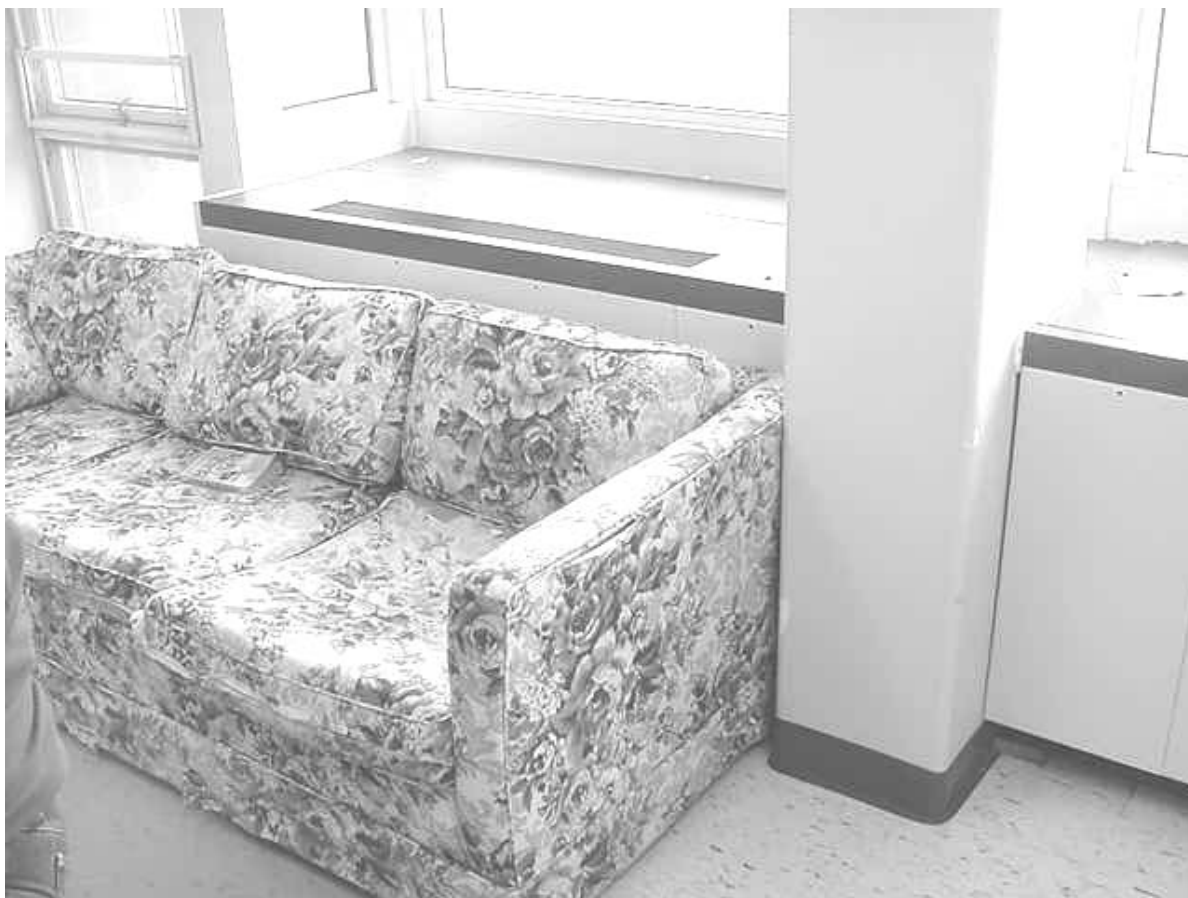
Picture 3

Sofa Obstructing Univent Return Vent (Along Front of Unit)

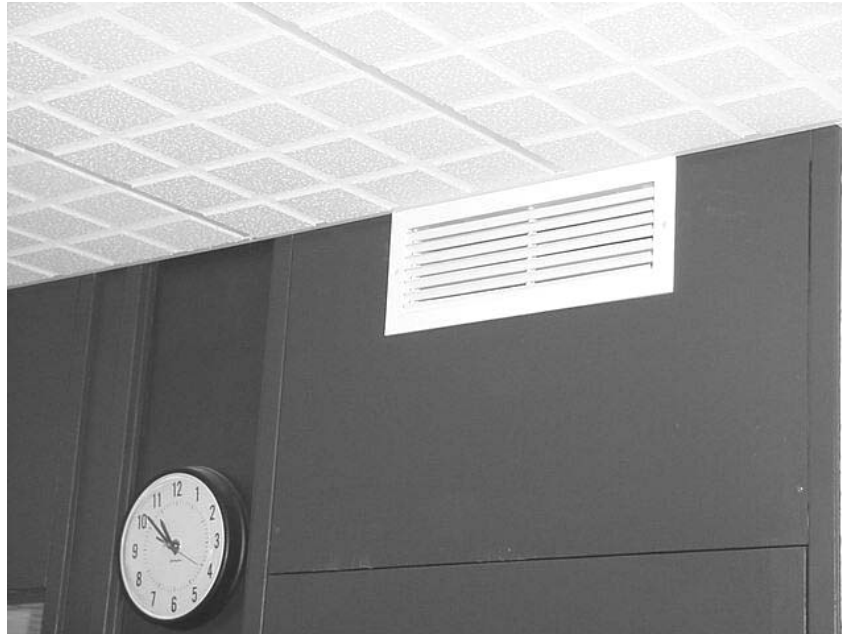
Picture 4

The mechanical exhaust ventilation system consists of ceiling and wall-mounted exhaust vents (see Picture 4). These vents were operating throughout the building with the exception of classroom M-312. Little or no draw of air was detected in this classroom (see Tables), which can indicate that either the exhaust ventilation was turned off, or that the rooftop motor was not functioning. The location of some exhaust vents can also limit exhaust efficiency when the classroom hallway door is open (see Picture 5). When a classroom door is open, exhaust vents will tend to draw air from both the hallway and the classroom. The open hallway door reduces the effectiveness of the exhaust vent to remove common environmental pollutants from classrooms. The exhaust vents in the library are located behind heating pipes (see Picture 6). This blockage can reduce the draw of air to these vents by fifty percent. Without removal by the exhaust ventilation, normally occurring environmental pollutants can build up and lead to indoor air complaints.

Wall-Mounted Exhaust Vent

1. Examine rooftop exhaust motors and AHUs detailed in the ventilation section of this report for proper function. Repair/replace belts and parts as necessary.

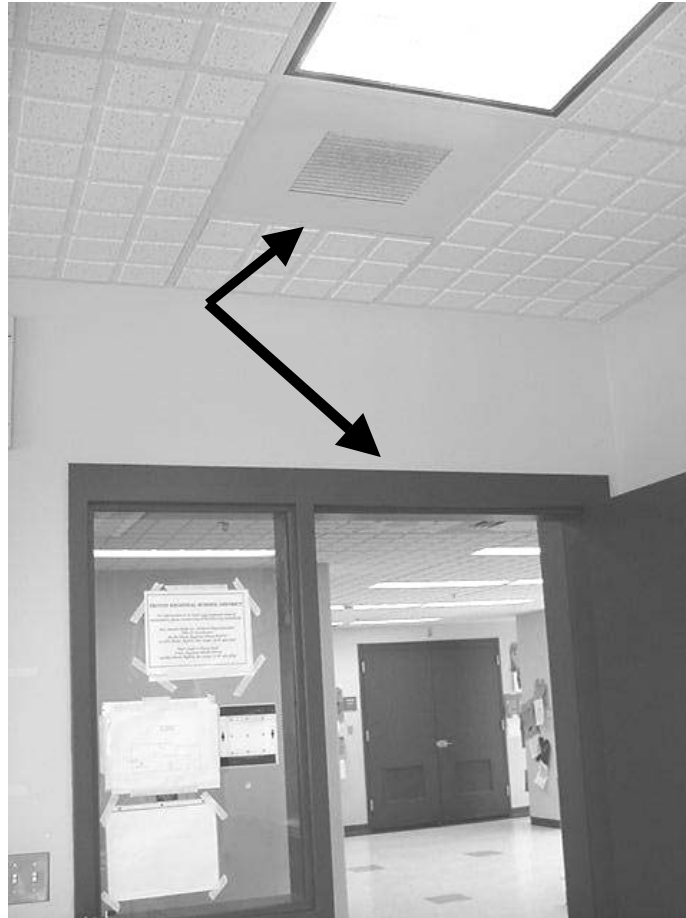
Picture 5

Ceiling-Mounted Exhaust Vent and Open Classroom/Hallway Door

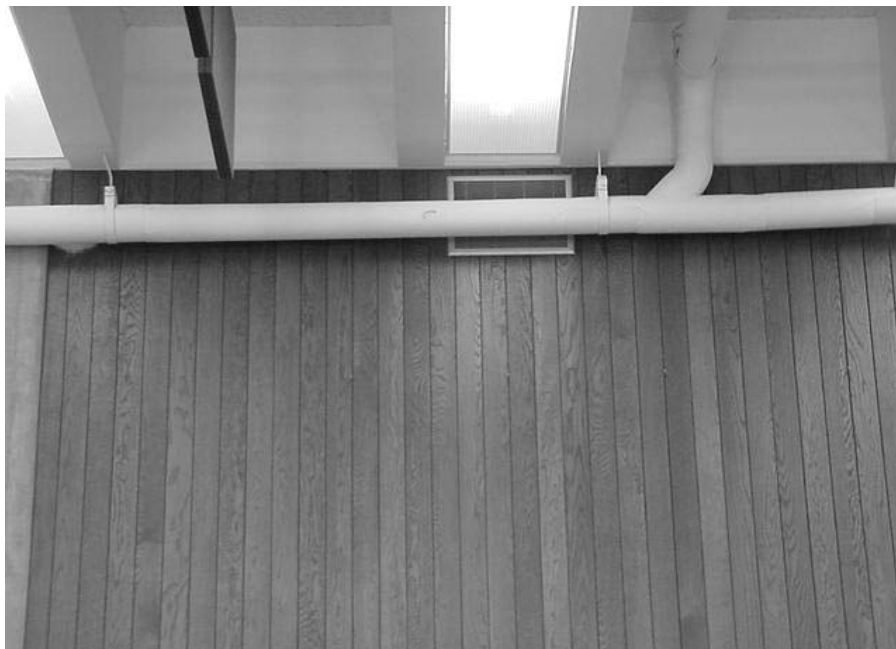
Picture 6

Library Exhaust Vent Obstructed By Pipe

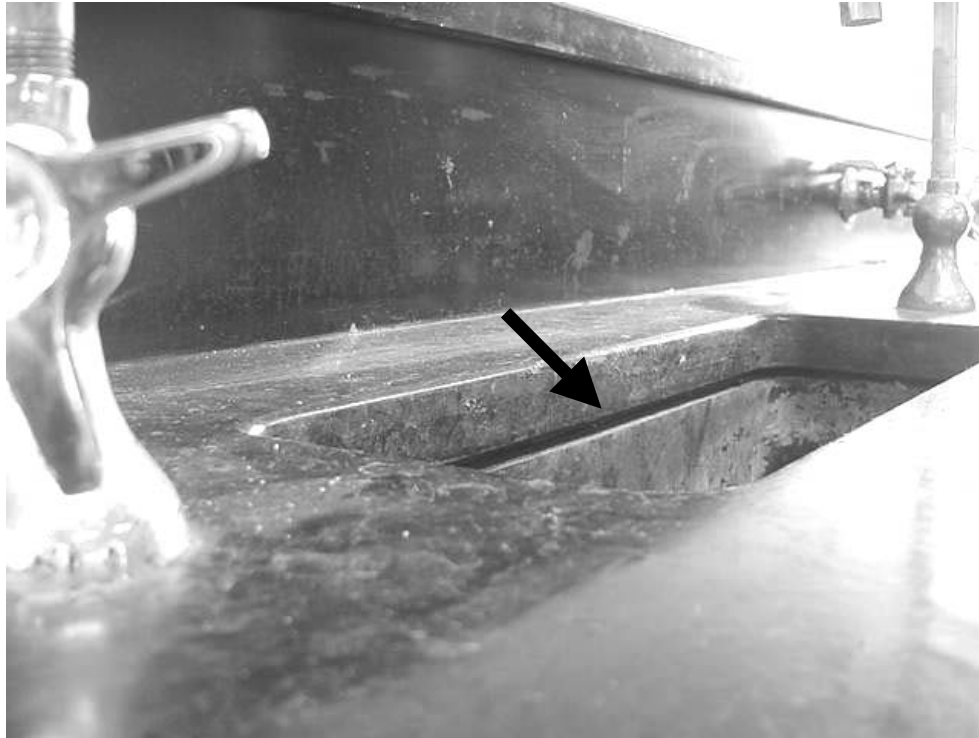
Picture 7

Spaces were noted between countertops and sinks in science classrooms (see Picture 7). Water-damaged flooring was seen below the sink in classroom H119 (see Pictures 8 & 9). School officials reported that the plumbing/sink in the classroom were installed in a manner that creates a seam that disconnects the sink from the counter. Inadequate drainage or overflow could lead to water penetration of countertop wood and potential damage to the cabinet, as well as to stored materials located therein. If wooden cabinets and porous materials become wet repeatedly, they can provide a medium for microbial growth.

Space Between Sink and Countertop in Science Classroom

7. Clean upholstered furniture on the schedule recommended in this report. If not possible/practical, remove upholstered furniture from classrooms.
8. Seal around sinks in science areas. Repair any existing plumbing leaks and replace any remaining water-damaged building materials. Examine around these areas for mold growth. Disinfect areas of water leaks with an appropriate antimicrobial as needed.

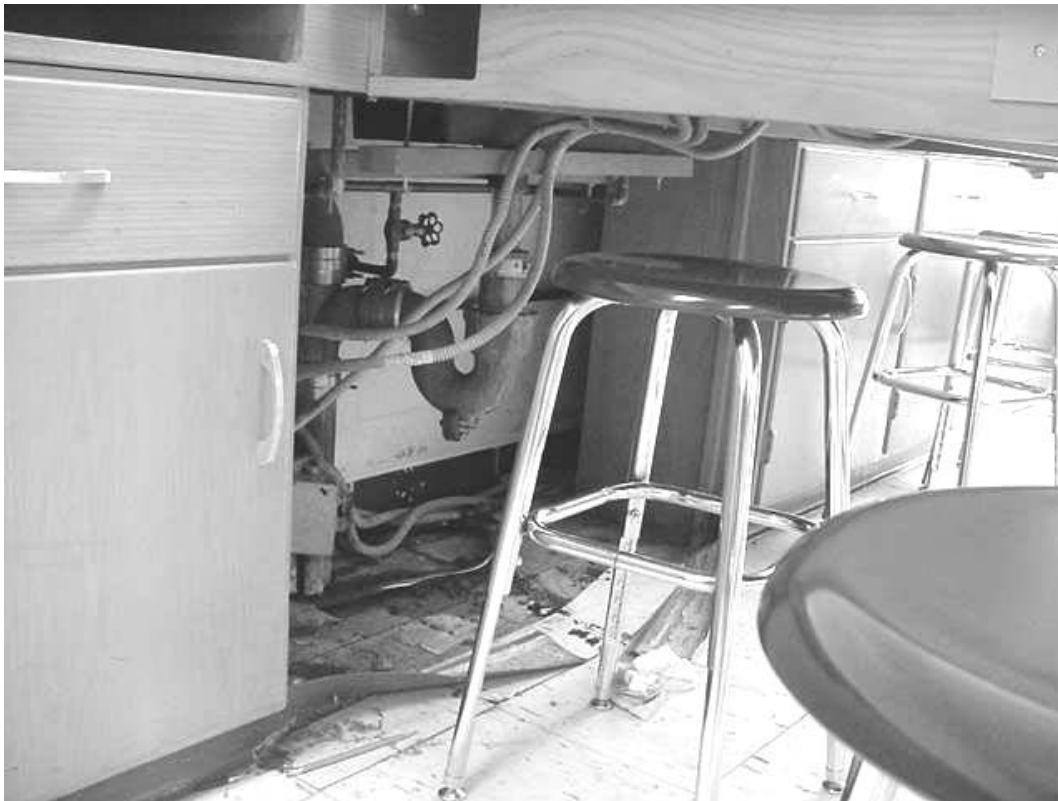
Picture 8

Water Damaged Flooring beneath Sink

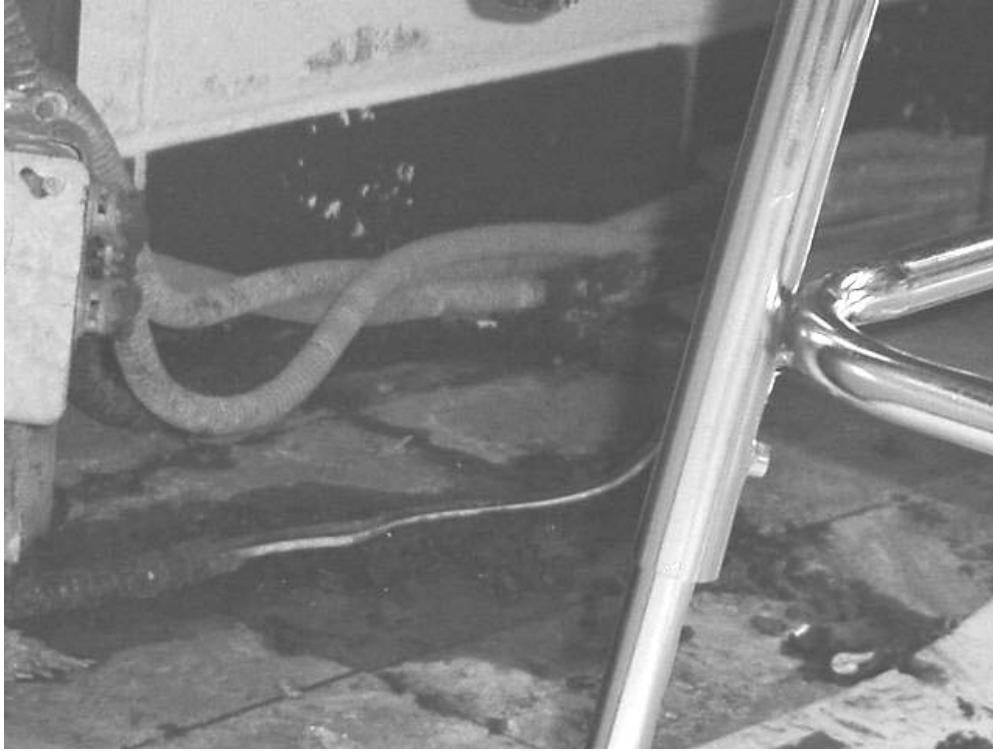
Picture 9

Close-Up Of Water Damaged Floor In Previous Picture

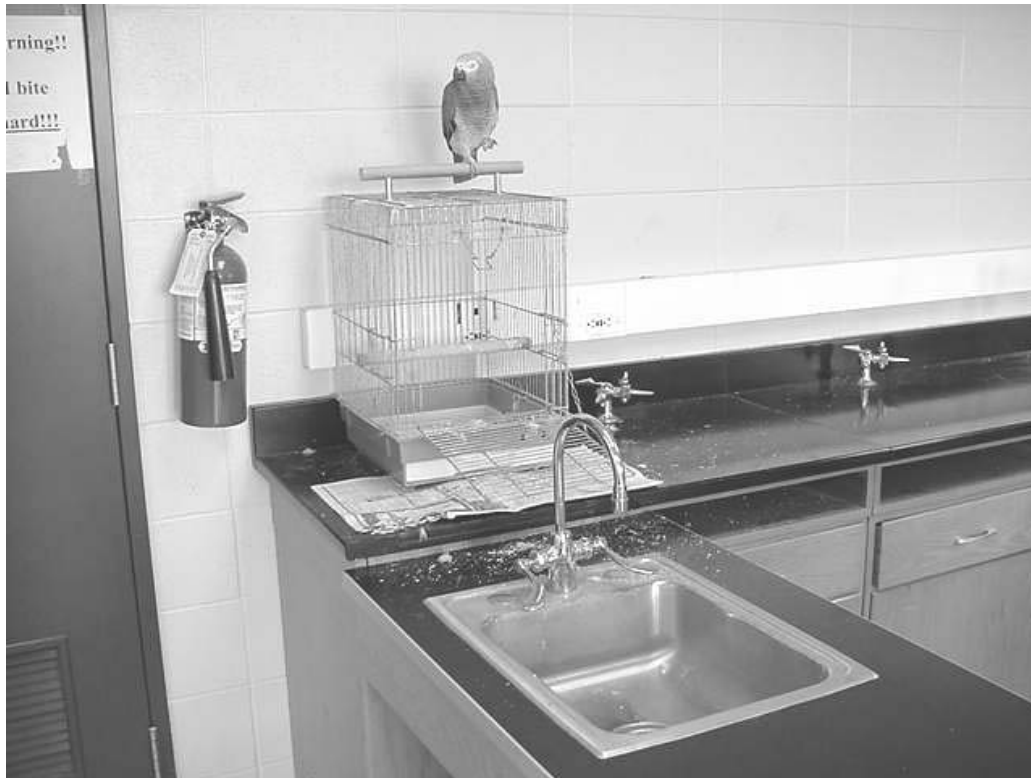
Picture 10

Classroom H-108 contained a parrot and others contained rabbits. The rabbit cages, birdcage and the surrounding countertop areas were littered with bird wastes and/or wood shavings (see Picture 10). Porous materials (i.e., wood shavings) can absorb animal wastes and can be a reservoir for mold and bacterial growth. Animal dander, feathers and wastes can all be sources of respiratory irritants. Animal cages and surrounding areas should be cleaned regularly to avoid the aerosolization of allergenic materials and/or odors.

Parrot and Birdcage in Classroom H-108, Note Materials on Surrounding Countertop

9. Clean and maintain animal cages to prevent bacterial/mold growth and/or odors.
10. Evaluate science chemical flow hoods in order to determine proper function to contain vapors in accordance with ANSI/ASHRAE 110-1995 section 6.

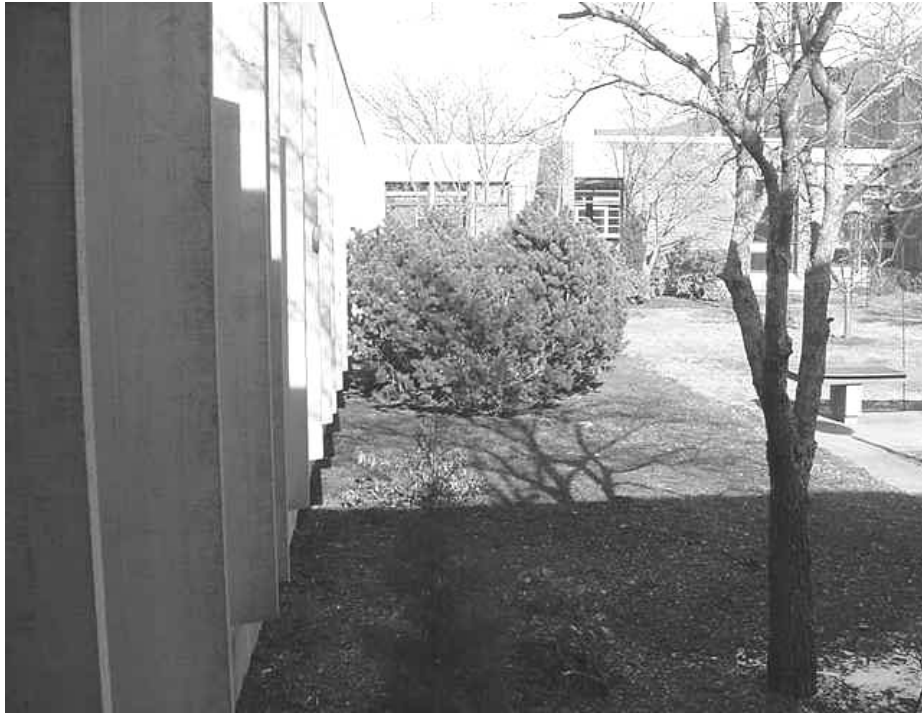
Picture 11

Shrubbery in direct contact with the exterior wall brick was noted in several areas around the building (see Picture 11). Shrubbery can serve as possible sources of water impingement on the exterior curtain wall due to the location of plants growing directly against the building. Plants retain water and in some cases can work their way into mortar and brickwork causing cracks and fissures, which may subsequently lead to water penetration and possible mold growth.

Shrubbery In Contact With Exterior Wall

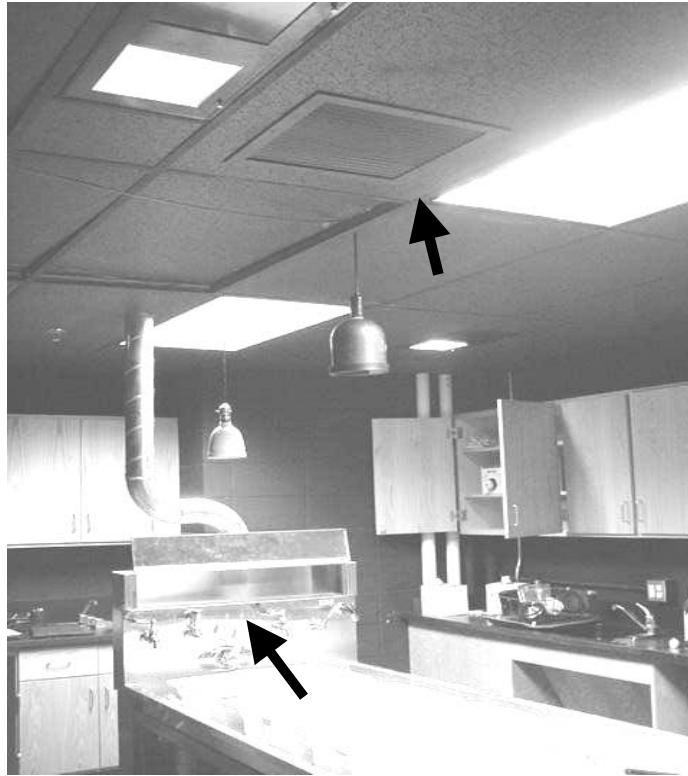
Picture 12

Photo Developing Sink Note Local Exhaust System And Ceiling-Mounted Exhaust Vent

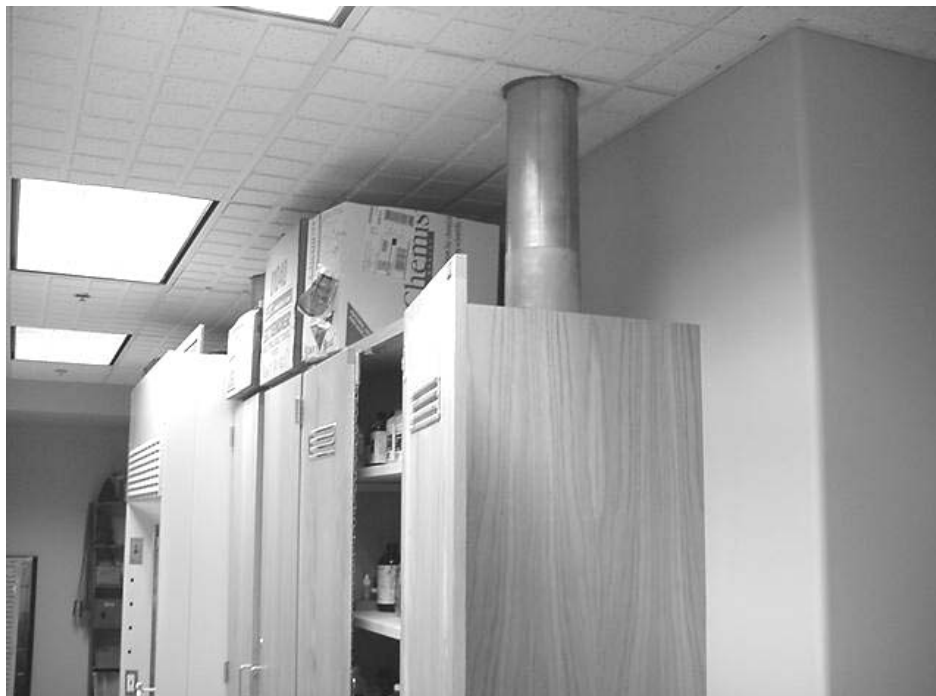
Picture 13

The storage of chemicals in the science area poses a number of potential indoor air quality and safety hazards. The cabinet that contains chemistry materials appears to be a flameproof cabinet that is connected by a duct to a non-motorized exhaust vent on the roof (see Picture 13). Without a motorized roof vent, this duct can backdraft, resulting in the off-gassing chemicals of stored containers being forced through the cabinet doors. Door fasteners have begun to corrode from such exposure (see Picture 14). A number of flammables and VOC containing chemicals (e.g., acetone, cyclohexane, t-butanol, toluene) are stored in this cabinet. Exposure to chemical vapors can be irritating to the eyes, nose and respiratory system. In addition, flammable materials should be stored in a cabinet that meets the requirements of the National Fire Prevention Association (NFPA) (NFPA, 1996). The NFPA does not require venting in flammable storage cabinets, however, if venting is done, it must be vented directly outdoors and in a manner not to compromise the specific performance of the cabinet (NFPA, 1996). In this configuration, it would not be expected that this cabinet would perform to prevent the spread of fire to stored chemicals.

Chemical Storage Cabinet, Note Vent

15. Consider obtaining a flammables storage cabinet for storing flammable materials in the chemistry storeroom. Seal the vent to the existing cabinet to prevent backdraft of cold outdoor air into the building via this route.

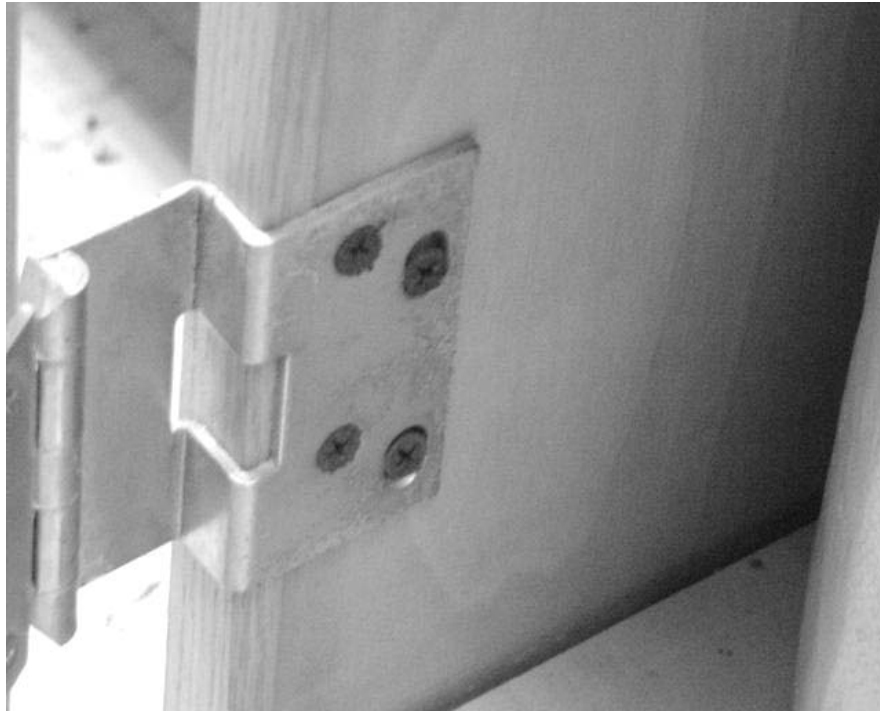
Picture 14

Corroded Fasteners On Chemical Storage Cabinet Door Hinge

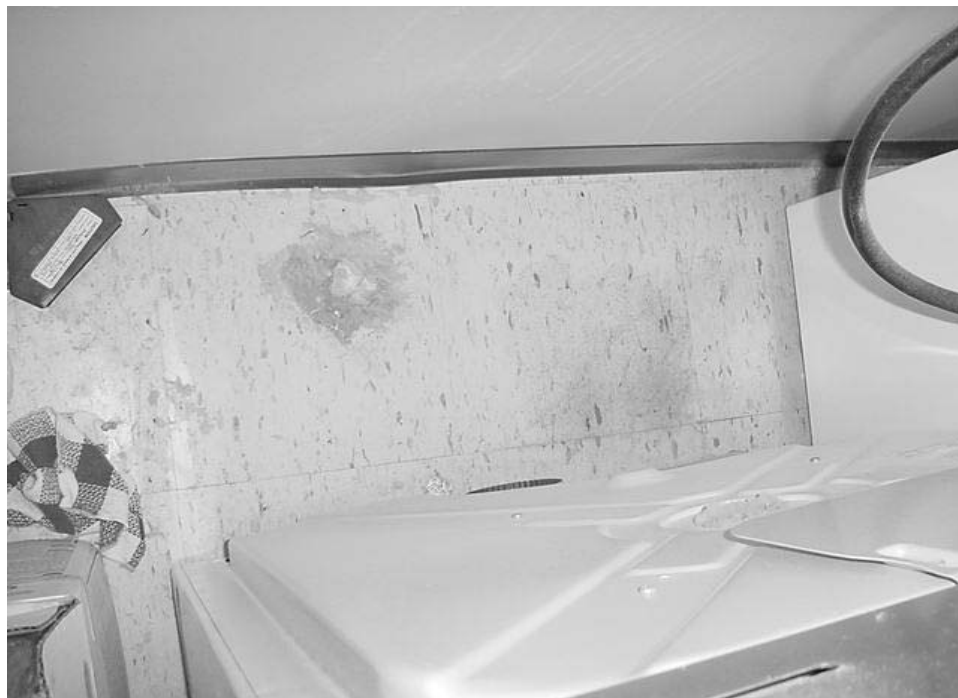
Picture 15

An unvented clothes dryer was observed in the consumer science room (see Picture 15). In this condition, both moisture and waste heat from the dryer are vented into this room. The combination of water vapor and collected lint can lead to microbial growth. Dryers should be vented to the outside of the building.

Unvented Clothes Dryer
